Technical Report EL-98-15
November 1998

Feasibility Study for Evaluating Redistribution of Juvenile Salmon in the McNary Bypass Channel Using Behavioral Technologies: 1996

Prepared for U.S. Army Engineer District, Walla Walla

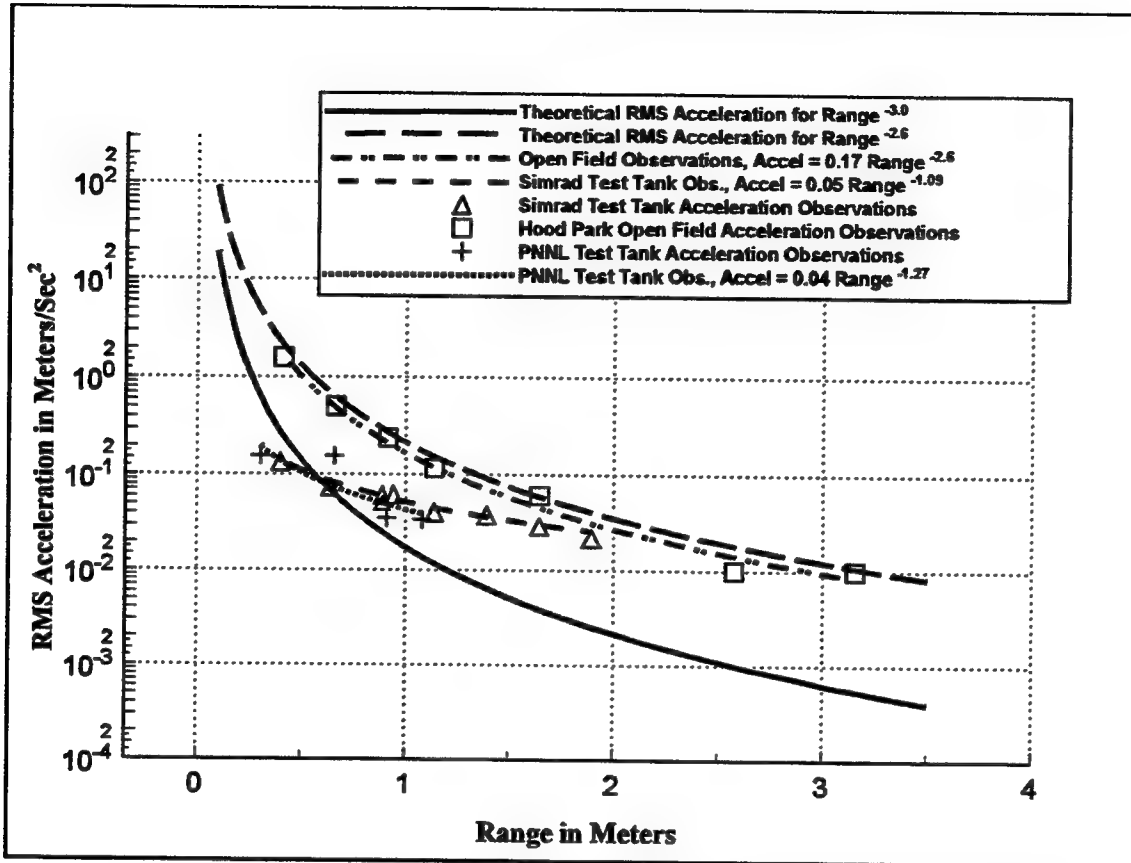
Figure 1. Comparison of tank, open field and theoretical RMS acceleration values as a function of distance from the infrasound source (from Carlson and Campana 1996)

Results of two other infrasound field characterization studies using the same infrasound source and triaxial accelerometer measurement device were compared with accelerations measured in the NPPL test tank. One set of sound field characterization measurements was made at the Simrad Production Facility, Seattle, WA, in a 3 m x 3 m x 3 m test tank. Another set of measurements was made under open field conditions in the Snake River at Hood Park, WA (Carlson and Campana 1996). Results of all three studies, as well as estimates of expected water particle acceleration based on local flow theory presented by Kalmijn (1988), are presented in Figure 1. The comparison reveals the observations of water particle acceleration in the two test tanks (PNPL and Simrad) were very similar to each other, below those observed under open field conditions, but higher than expected from theory. The open field observations showed water particle acceleration values considerably above those expected from theory with a decay constant of 2.6 in contrast to the theoretical decay constant of 3.0. The tank data sets showed the smallest rate of decrease in water particle acceleration with a decay constant of approximately 1.0. The trends in the test tank data indicated that while water particle acceleration in the tank was below that at the same range under free field conditions, at longer ranges it was likely that tank water particle acceleration would approach and perhaps exceed that for the free field. The slower decay under conditions in the tank is likely due to the nearness of the boundaries in the tank and resulting

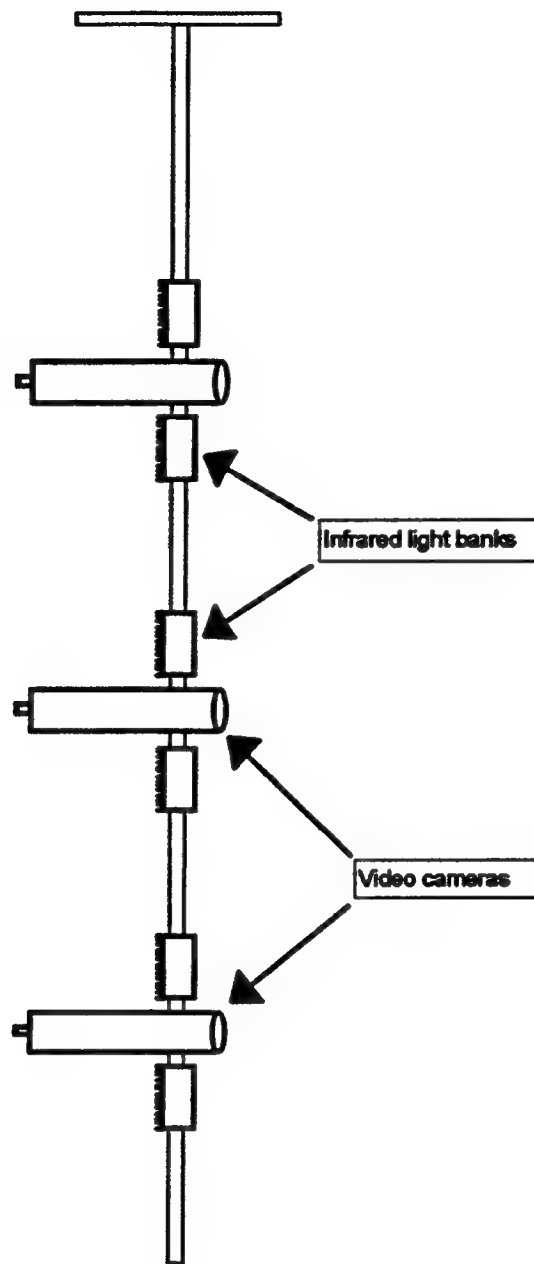
Figure 4. Pole-mounted cameras and infrared light banks used for video evaluations of McNary juvenile bypass in June, 1996. Each camera's field of view was illuminated with 2 infrared light banks.

On June 25, 1996, we deployed pole-mounted cameras and lights (Figure 4) in the transition zone of the bypass channel between the side- and floor-dewatering areas.

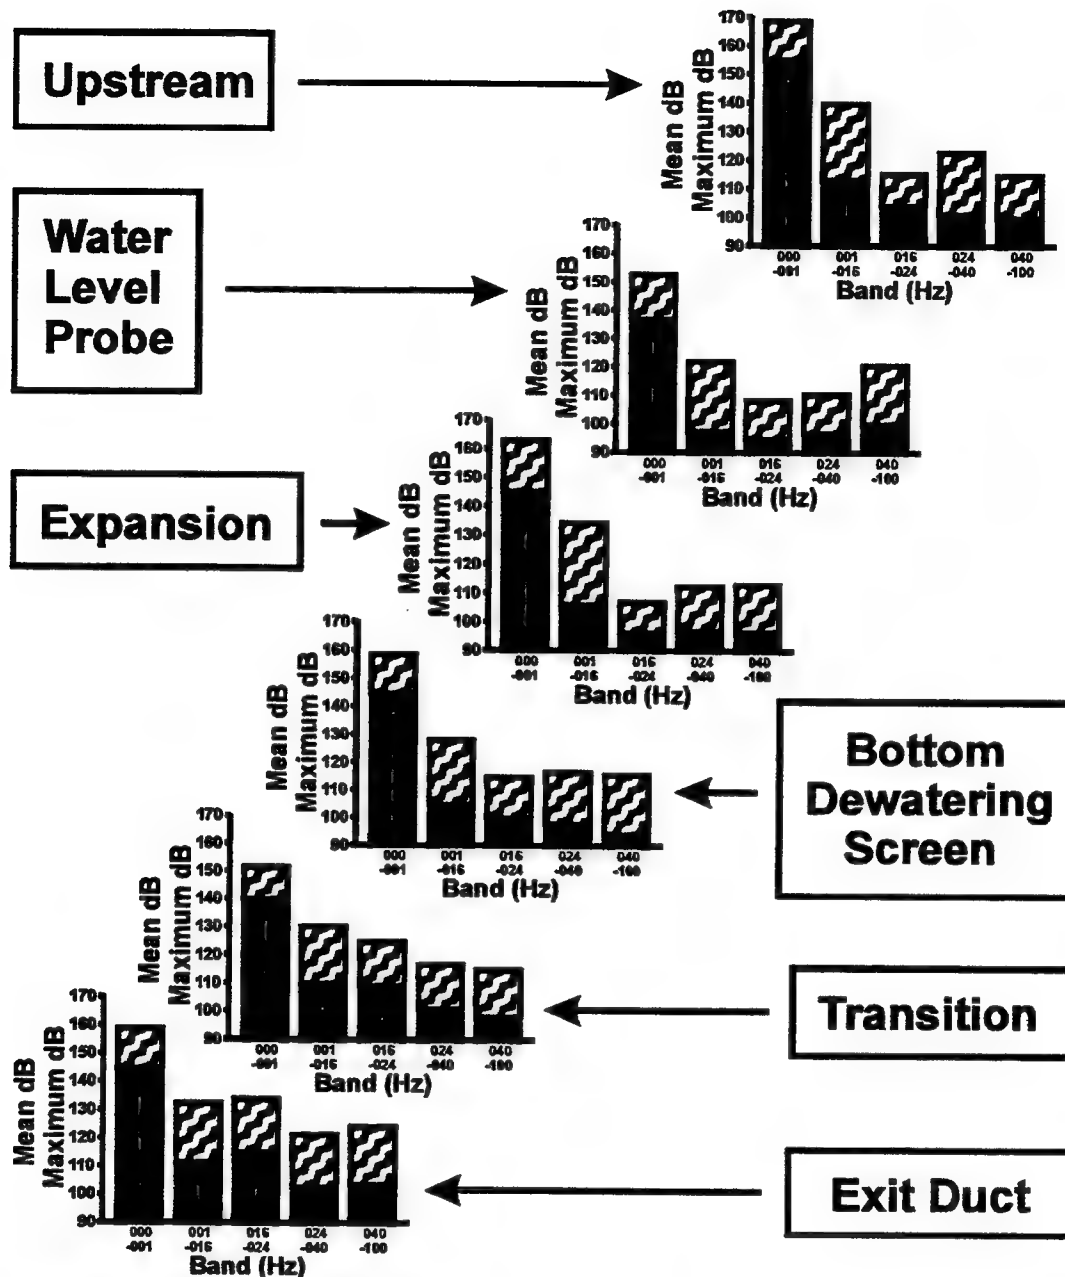
Figure 5. Longitudinal distribution of mean and maximum sound pressure (dB // 1 μ pascal) in selected bands at .6 M depth in the dewatering section of the McNary Juvenile Bypass System from the exit duct to the downstream end of the side dewatering screen.

All stations measured with the MSFS showed the presence of very high sound pressure levels in the 0.125 to 1 Hz range. A number of readings were obtained having pressure levels greater than 165 dB // 1 μ pa (Figure 5) with a maximum reading of 172 dB // 1 μ pa. No pattern in the distribution of readings was noted. Results from the accelerometer confirmed the presence of a substantial vibration of the channel lining at this frequency. Given the pervasive nature of the sound, the high sound pressure levels obtained, and other observations made at the site, we conclude that the 0.5 Hz signal is probably not entirely due to a propagated sound wave but also has a major hydrodynamic local flow and or bulk flow component. We observed flows surging through the small adjustable side gates at the most downstream end of the sluiceway and suspect that flows within the channel are hydraulically unstable. Unlike most situations in which the vibration of the hydraulic structure provides the source of underwater sound, the turbulence may be exciting the structure to vibrate.

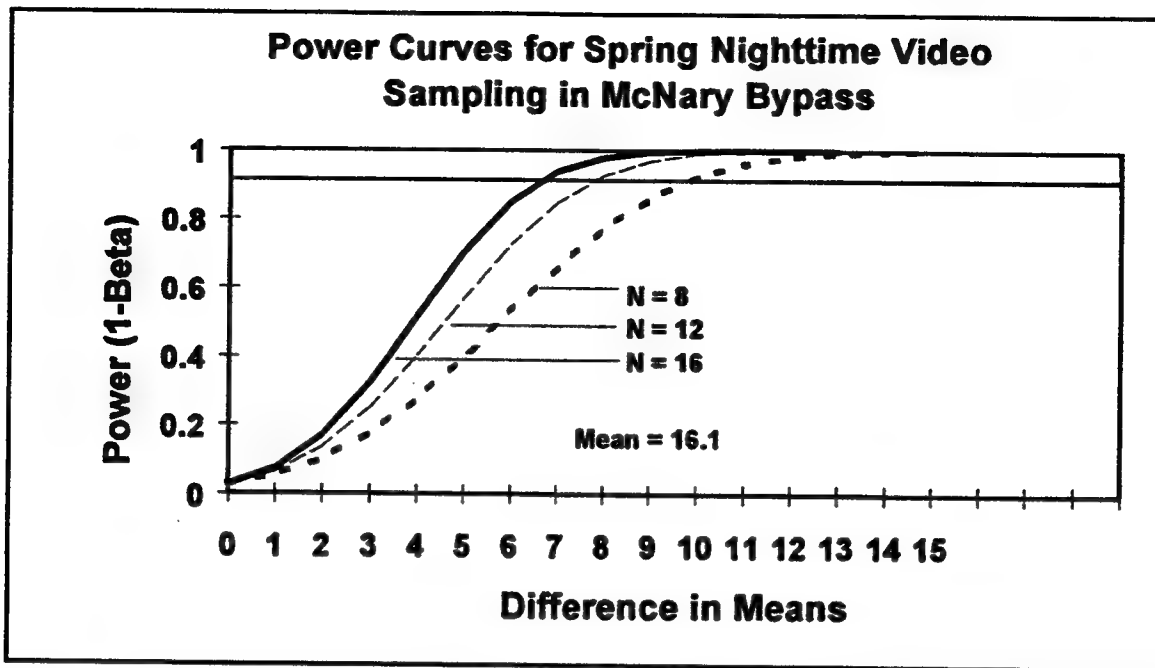
Figure 7. Power of the test curves for varying sample sizes using video sampling in McNary bypass channel. Sample size represents paired hours of on-off treatments. Curves are used to determine required sample size given desired level of mean difference detection. Sample size of $n=12$ will allow for 90% power to reject the null hypothesis of no difference given a 50% difference in the means.
